# Manhole Inspection Summary

Manhole # S29K\_\_002MH

Insp Date: **10/27/08 11:38 AM**

**Location** Address: **228 Otterbein St**

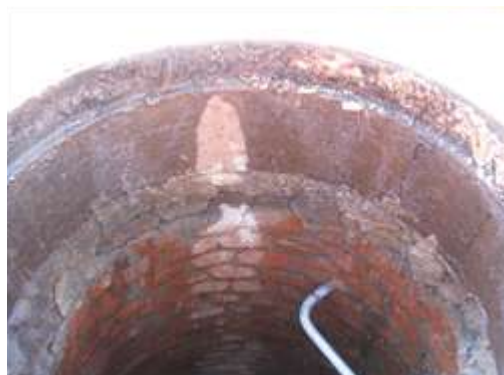
Defect 3

☒ **Leaks**

Infiltration: ☐ None ☒ **Joint** ☐ Cracks ☐ Mortar ☐ Roots ☐ Wall

infiltration from frame and chimney joint

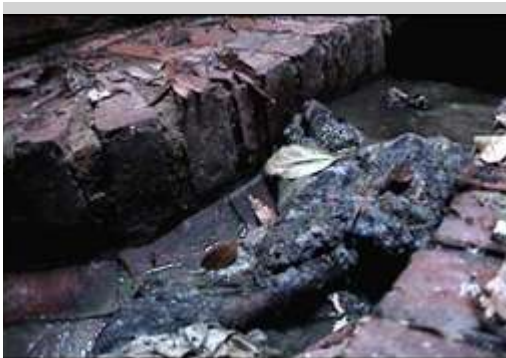
Defect 2

Condition: ☐ Sound ☐ Cracked ☐ Root Intrusion ☐ Deteriorated ☐ Leaks ☒ **Debris**

heavy debris in channel

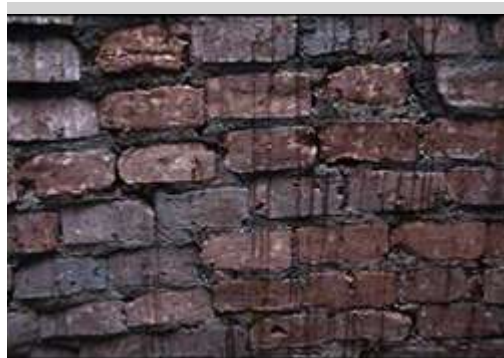
Defect 1

Infiltration: ☐ None ☐ Joint ☐ Cracks ☐ Mortar ☐ Roots ☒ **Wall**

signs of infiltration on corbel wall

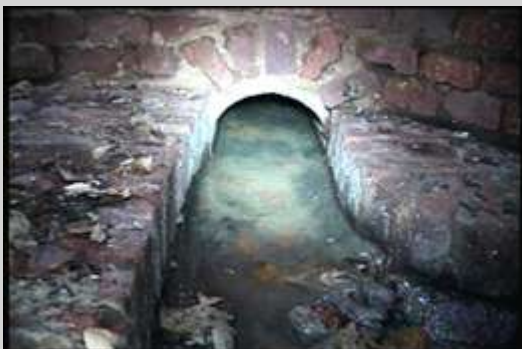
8 in. Circular Gravity Sewer  
Pipe In @ 9 O'Clock

Pipe Height: **8.4** (in.) Rod and Bar (Angled)  
Pipe Material: **Clay** ☐ Pipe Lined  
Invert Depth: **9.32** (ft.) Flow Characteristics: **Fast**  
Deposits: ☐ None ☐ Mud ☒ ~~Gravy~~ ☒ Debris ☐ Grease  
Silt Depth: **2** (in.) Deposits Extent: **Light**  
Infiltration: **None** Pipe Seal Cond: **Sound**

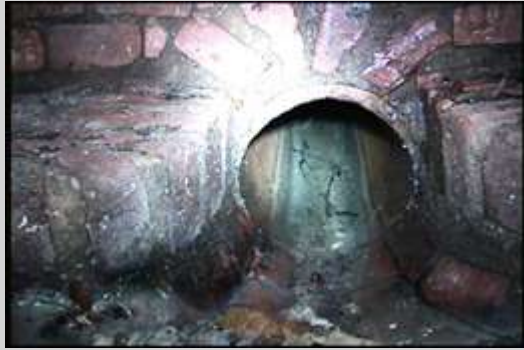
8 in. Circular Gravity Sewer  
Pipe Out @ 12 O'Clock

Deposits: ☐ None ☐ Mud ☒ **Sludge** ☒ **Debris** ☐ Grease

Silt Depth: **2** (in.) Deposits Extent: **Light**
